SZS CONSULTING GROUP

ADA ASSESSMENT & REVIEW
Monterey County Jail

Hernandez v. County of Monterey, et. al.
Case No.CV13-2354 PSG

November 30, 2013

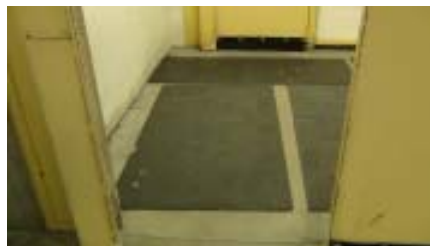
Field Date:	10/28/2013	Report Date:	11/12/2013	Barrier #:	1A
Bldg Name:	Monterey County Jail				
Location:	Control 1 - Receiving Area				
X Coordinate:	N/A	Y Coordinate:	N/A		
Barrier Area:	Doors or Gates				
Barrier Type:	Doormats				
Code Ref:	CBC 1133B.1.1.1.3				
As Built Meas:	1	Quantity:	EACH		
Description:	Recessed doormat not anchored to floor (trip hazard)				
As Built Desc:	Doormat not anchored to floor				
Solution:	Anchor door mat to prevent trip hazards				
Bar. Severity:	1 Necessary	Cost Estimate:	500	Status:	Open
Implementation Priority:	2	Facility Function:	Public		
Implementation Phase:		Implementation Date:			
Official Responsible:	Monterey County				
Notes:

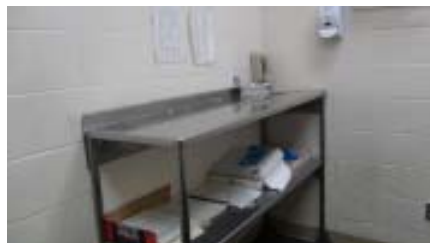
Field Date:	10/28/2013	Report Date:	11/12/2013	Barrier #:	1B
Bldg Name:	Monterey County Jail				
Location:	Control 1 - Receiving Area				
X Coordinate:	N/A	Y Coordinate:	N/A		
Barrier Area:	Counters and Tables				
Barrier Type:	Counter - Knee Clearance				
Code Ref:	CBC 1122B.5 and 2010 ADAS 305.3				
As Built Meas:	1	Quantity:	EACH		
Description:	Counter lacks surface height between 28" and 34" high				
As Built Desc:	Counter surface height measured at 43" high				
Solution:	Replace counter to provide min. 3 ft section at accessible height				
Bar. Severity:	3 Hindrance	Cost Estimate:		Status:	Open
Implementation Priority:	2	Facility Function:	Public		
Implementation Phase:		Implementation Date:			
Official Responsible:	Monterey County				
Notes:	Inmates use counter to fill out forms, etc.

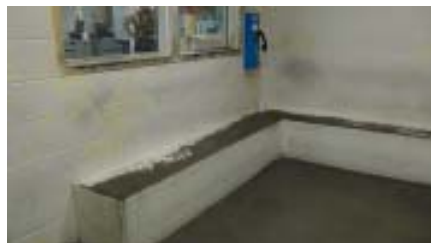
Field Date:	10/28/2013	Report Date:	11/12/2013	Barrier #:	2A
Bldg Name:	Monterey County Jail				
Location:	Control 1 - Booking 1 - New Arrival/General Population				
X Coordinate:	N/A	Y Coordinate:	N/A		
Barrier Area:	Detention Facilities				
Barrier Type:	Accessible Passageway - Vision Lights in Door or Gate				
Code Ref:	2010 ADAS 404.2.11				
As Built Meas:	1	Quantity:	EACH		
Description:	Bottom edge of vision panel adjacent to door or gate not max. 43" above floor/ground				
As Built Desc:	View panels in door and wall measured at 43-1/2" high				
Solution:	Replace door or replace vision panel in door				
Bar. Severity:	4 Low Severity	Cost Estimate:	2250	Status:	Open
Implementation Priority:	2	Facility Function:	Public		
Implementation Phase:		Implementation Date:			
Official Responsible:	Monterey County				
Notes:	People of short stature or wheelchair users require lower vision panels for equal access

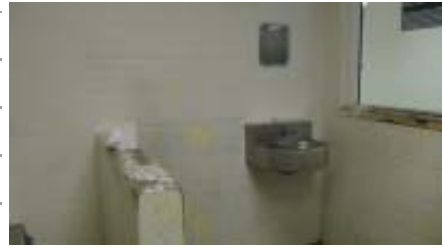
Field Date:	10/28/2013	Report Date:	11/12/2013	Barrier #:	2F
Bldg Name:	Monterey County Jail				
Location:	Control 1 - Booking 1 - New Arrival/General Population				
X Coordinate:	N/A	Y Coordinate:	N/A		
Barrier Area:	Detention Facilities				
Barrier Type:	Sanitary Facilities - Lavatory Knee Clearance				
Code Ref:	CBC 1115B.4.4				
As Built Meas:	1	Quantity:	JOB		
Description:	Lavatory rim or counter edge is higher than 34" AFF				
As Built Desc:	Lavatory rim measured at 35-1/2" high				
Solution:	Replace lavatory to provide access for wheelchair users and short people				
Bar. Severity:	1 Necessary	Cost Estimate:	450	Status:	Open
Implementation Priority:	2	Facility Function:	Public		
Implementation Phase:		Implementation Date:			
Official Responsible:	Monterey County				
Notes:

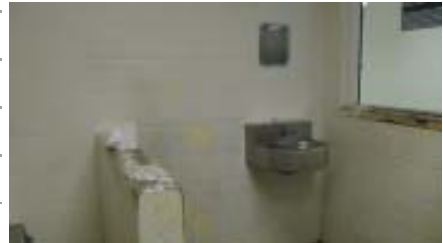
Field Date:	10/28/2013	Report Date:	11/12/2013	Barrier #:	2G
Bldg Name:	Monterey County Jail				
Location:	Control 1 - Booking 1 - New Arrival/General Population				
X Coordinate:	N/A	Y Coordinate:	N/A		
Barrier Area:	Detention Facilities				
Barrier Type:	Sanitary Facilities - Lavatory Centerline				
Code Ref:	CBC 1115B.4.3.1				
As Built Meas:	1	Quantity:	JOB		
Description:	Lavatory adjacent to wall not min. 18" to the centerline of fixture				
As Built Desc:	Lavatory centerline measured at 16-1/2" from wall				
Solution:	Relocate or replace lavatory to provide wheelchair access				
Bar. Severity:	2 Recommended	Cost Estimate:	450	Status:	Open
Implementation Priority:	2	Facility Function:	Public		
Implementation Phase:		Implementation Date:			
Official Responsible:	Monterey County				
Notes:

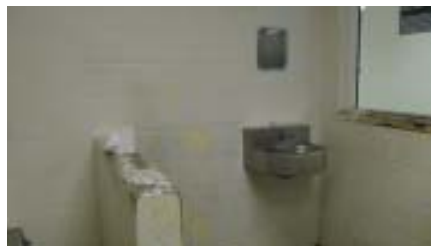
Field Date:	10/28/2013	Report Date:	11/12/2013	Barrier #:	2H
Bldg Name:	Monterey County Jail				
Location:	Control 1 - Booking 1 - New Arrival/General Population				
X Coordinate:	N/A	Y Coordinate:	N/A		
Barrier Area:	Detention Facilities				
Barrier Type:	Sanitary Facilities - Lavatory Faucet				
Code Ref:	CBC 1115B.4.1				
As Built Meas:	1	Quantity:	JOB		
Description:	Lavatory faucet requires more than 5 lbf (22.2 N) to activate				
As Built Desc:	Lavatory faucet requires more than 5 lbf to activate				
Solution:	Replace faucet to provide access for people with hand impairments				
Bar. Severity:	1 Necessary	Cost Estimate:	375	Status:	Open
Implementation Priority:	2	Facility Function:	Public		
Implementation Phase:		Implementation Date:			
Official Responsible:	Monterey County				
Notes:

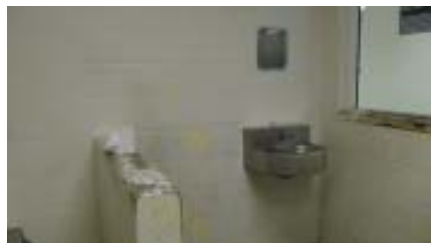
Field Date:	10/28/2013	Report Date:	11/12/2013	Barrier #:	2I
Bldg Name:	Monterey County Jail				
Location:	Control 1 - Booking 1 - New Arrival/General Population				
X Coordinate:	N/A	Y Coordinate:	N/A		
Barrier Area:	Detention Facilities				
Barrier Type:	Sanitary Facilities - Mirror				
Code Ref:	CBC 1115B.8.1.1				
As Built Meas:	1	Quantity:	EACH		
Description:	Mirror at lavatory/countertop not max. 40" AFF at edge of reflecting surface				
As Built Desc:	Mirror (reflective surface) measured at 55" high				
Solution:	Replace or remount mirror				
Bar. Severity:	3 Hindrance	Cost Estimate:	375	Status:	Open
Implementation Priority:	2	Facility Function:	Public		
Implementation Phase:		Implementation Date:			
Official Responsible:	Monterey County				
Notes:

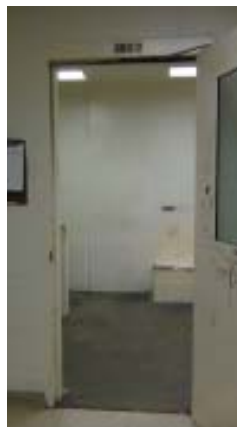
Field Date:	10/28/2013	Report Date:	11/12/2013	Barrier #:	3A
Bldg Name:	Monterey County Jail				
Location:	Control 1 - Booking 2 - Waiting Housing/General Populati				
X Coordinate:	N/A	Y Coordinate:	N/A		
Barrier Area:	Detention Facilities				
Barrier Type:	Accessible Passageway - Vision Lights in Door or Gate				
Code Ref:	2010 ADAS 404.2.11				
As Built Meas:	1	Quantity:	EACH		
Description:	Bottom edge of vision panel adjacent to door or gate not max. 43" above floor/ground				
As Built Desc:	View panel measured at 43-1/2" high				
Solution:	Replace door or replace vision panel in door				
Bar. Severity:	4 Low Severity	Cost Estimate:	2250	Status:	Open
Implementation Priority:	2	Facility Function:	Public		
Implementation Phase:		Implementation Date:			
Official Responsible:	Monterey County				
Notes:	People of short stature or wheelchair users require lower vision panels for equal access

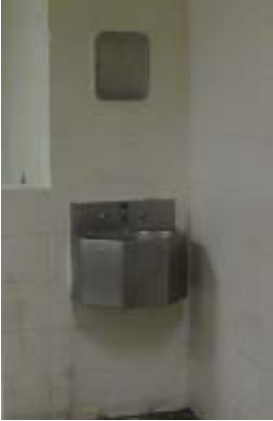
Field Date:	10/28/2013	Report Date:	11/12/2013	Barrier #:	4H

Bldg Name:	Monterey County Jail					
Location:	Control 1 - Booking 3 - SNY Holding					
X Coordinate:	N/A	Y Coordinate:	N/A			
Barrier Area:	Detention Facilities					
Barrier Type:	Sanitary Facilities - Lavatory Knee Clearance					
Code Ref:	CBC 1115B.4.3.2					
As Built Meas:	1	Quantity:	JOB			
Description:	Lavatory bottom apron/edge not max 29" reducing to 27" at 8" back from edge					
As Built Desc:	Lavatory knee clearance measured at 22-1/2" high					
Solution:	Replace lavatory. This model cannot provide accessible knee clearance					
Bar. Severity:	1 Necessary	Cost Estimate:	450	Status:	Open	
Implementation Priority:	2	Facility Function:	Public			
Implementation Phase:		Implementation Date:				
Official Responsible:	Monterey County					
Notes:	A wheelchair accessible lavatory cannot measure more than 9" from rim to bottom edge. This fixture ca

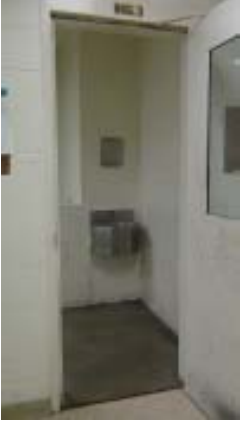
Field Date:	10/28/2013	Report Date:	11/12/2013	Barrier #:	4I

Bldg Name:	Monterey County Jail					
Location:	Control 1 - Booking 3 - SNY Holding					
X Coordinate:	N/A	Y Coordinate:	N/A			
Barrier Area:	Detention Facilities					
Barrier Type:	Sanitary Facilities - Mirror					
Code Ref:	CBC 1115B.8.1.1					
As Built Meas:	1	Quantity:	EACH			
Description:	Mirror at lavatory/countertop not max. 40" AFF at edge of reflecting surface					
As Built Desc:	Mirror (reflective surface) measured at 55" high					
Solution:	Replace or remount mirror					
Bar. Severity:	3 Hindrance	Cost Estimate:	375	Status:	Open	
Implementation Priority:	2	Facility Function:	Public			
Implementation Phase:		Implementation Date:				
Official Responsible:	Monterey County					
Notes:

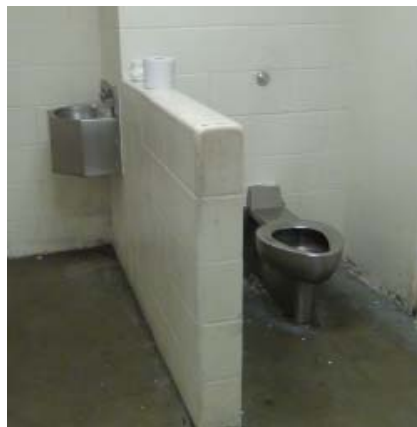
Field Date:	10/28/2013	Report Date:	11/12/2013	Barrier #:	5K
Bldg Name:	Monterey County Jail				
Location:	Control 1 - Booking 4 - Women Holding Cell				
X Coordinate:	N/A	Y Coordinate:	N/A		
Barrier Area:	Detention Facilities				
Barrier Type:	Sanitary Facilities - Toilet Handle				
Code Ref:	CBC 1115B.4 #4.1				
As Built Meas:	1	Quantity:	JOB		
Description:	Handle mounted higher than 44" AFF				
As Built Desc:	Push button flush control higher than 44" behind toilet				
Solution:	Replace control with water closet				
Bar. Severity:	3 Hindrance	Cost Estimate:	850	Status:	Open
Implementation Priority:	2	Facility Function:	Public		
Implementation Phase:		Implementation Date:			
Official Responsible:	Monterey County				
Notes:	Location of flush control not accessible and operation requires more than 5 lbf

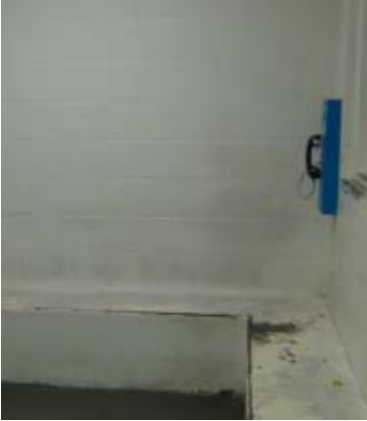
Field Date:	10/28/2013	Report Date:	11/12/2013	Barrier #:	6P

Bldg Name:	Monterey County Jail					
Location:	Control 1 - Booking 5-11 - Single Booking					
X Coordinate:	N/A	Y Coordinate:	N/A			
Barrier Area:	Detention Facilities					
Barrier Type:	Communication Features - Clearance at Phones					
Code Ref:	2010 ADAS 807.3 and 704					
As Built Meas:	0	Quantity:	JOB			
Description:	Telephone handset devices lacks min. 30" x 48" clearance for wheelchair users					
As Built Desc:	Phone located behind bench					
Solution:	Move phone to accessible location or provide additional accessible phone in alterate location					
Bar. Severity:	2 Recommended	Cost Estimate:	0	Status:	Open	
Implementation Priority:	2	Facility Function:	Public			
Implementation Phase:		Implementation Date:				
Official Responsible:	Monterey County					
Notes:

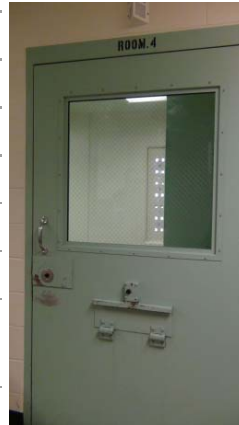
Field Date:	10/28/2013	Report Date:	11/12/2013	Barrier #:	33A
Bldg Name:	Monterey County Jail				
Location:	Control 3 - Infirmary Hospital Room 4				
X Coordinate:	N/A	Y Coordinate:	N/A		
Barrier Area:	Detention Facilities				
Barrier Type:	Accessible Passageway - Vision Lights in Door or Gate				
Code Ref:	2010 ADAS 404.2.11				
As Built Meas:	1	Quantity:	EACH		
Description:	Bottom edge of vision panel adjacent to door or gate not max. 43" above floor/ground				
As Built Desc:	View panel measured at 48" high				
Solution:	Replace door or replace vision panel in door				
Bar. Severity:	4 Low Severity	Cost Estimate:	2250	Status:	Open
Implementation Priority:	2	Facility Function:	Public		
Implementation Phase:		Implementation Date:			
Official Responsible:	Monterey County				
Notes:	People of short stature or wheelchair users require lower vision panels for equal access

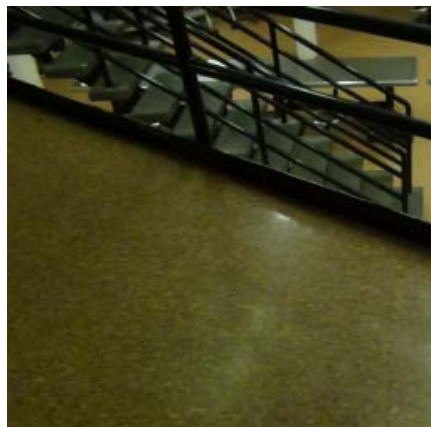
Field Date:	10/28/2013	Report Date:	11/12/2013	Barrier #:	84A
Bldg Name:	Monterey County Jail				
Location:	Control 4 - F Pod Common Area				
X Coordinate:	N/A	Y Coordinate:	N/A		
Barrier Area:	Detention Facilities				
Barrier Type:	Common Use Area - Protruding Stairway				
Code Ref:	CBC 1133B.8.6.1 and 2010 ADAS 307.2				
As Built Meas:	1	Quantity:	JOB		
Description:	Object protrudes more than 4" into pedestrian path				
As Built Desc:	Open stairway in center of common area creates a protruding hazard in path of travel				
Solution:	Provide detectable warning (guardrail) with leading edge at max. 6" above floor				
Bar. Severity:	1 Necessary	Cost Estimate:	4700	Status:	Open
Implementation Priority:	3	Facility Function:	Public		
Implementation Phase:		Implementation Date:			
Official Responsible:	Monterey County				
Notes:	F Pod has is an open housing unit with bunk beds

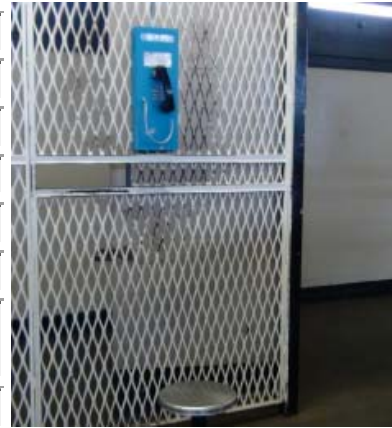
As Built Meas: 0 Quantity: JOB
 Description: Telephone controls are not max. 48" high
 As Built Desc: Phone measured at 65-1/2" high
 Solution: Relocate phones or provide alternate phones in accessible locations
 Bar. Severity: 2 Recommended Cost Estimate: 0 Status: Open
 Implementation Priority: 3 Facility Function: Public
 Implementation Phase: Implementation Date:
 Official Responsible: Monterey County
